THE VANISHING HOUSES OF KENT

4. BRIDGE FARM, BRIDGE

By E. W. PARKIN

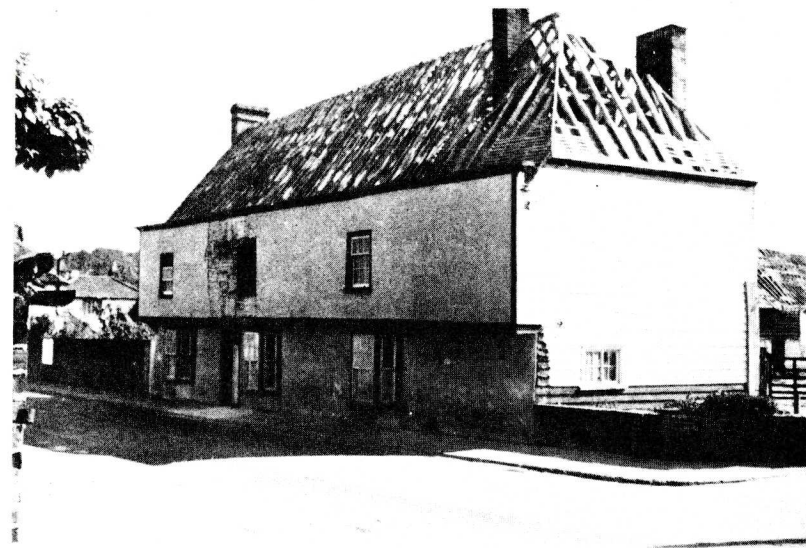
A. The house, seen from the road.

At first glance, the house appeared to be a very ordinary eighteenth-century one, with a front of stucco, sides of weatherboard, and with three small bays and a doorway on the street front (Plate IA). It was situated on the main Canterbury to Dover road, known as Watling Street, in the centre of the village and almost directly opposite the White Horse Inn. Behind it was a square farmyard with a large and ancient barn, two cow-sheds and other buildings (Fig. 1).

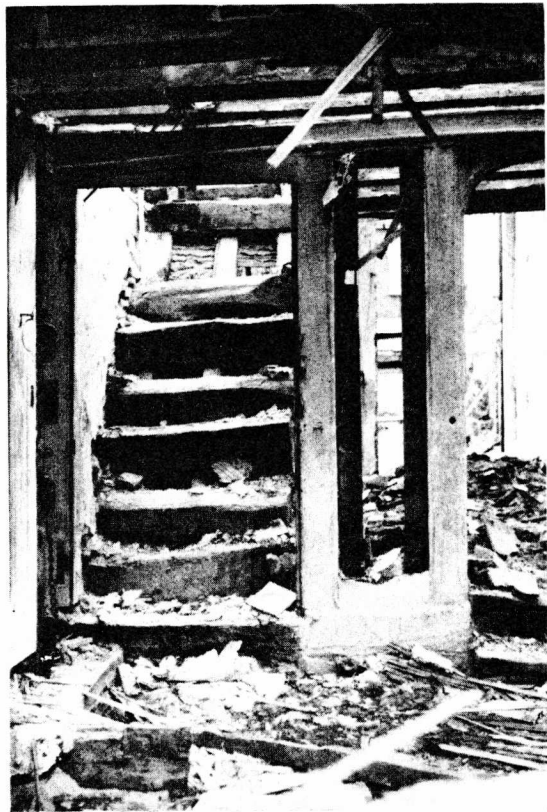
B. Remains of original stairway.

triangular section were nailed on to two sloping bearers, a third central bearer having been added at some later date. Each tread measured 3 ft. 3 in. by 7½ in., rising 8 to 9 in., the angle of the stairway being thus about 47 degrees from the horizontal. The bearers were 5½ in. wide by 3½ in. thick, and were nailed to a heavy beam at the top, and to a baulk of oak 8 in. square behind the door sill at the bottom. Each triangular step was fixed by only two large hand-made nails near the bottom edge, and although some of the nail heads had rusted completely away, all the steps except one were still firmly fixed (Fig. 3 and Plate IIB).
