Elegance restored

Broad Oak Water is considered to be the next most suitable major surface water resource development for Kent. If proposals by Mid Kent Water Plc. are approved this 16th Century farmhouse will be flooded. As a consequence of these long-standing plans the building had fallen into disrepair and had been utilised by squatters. Archaeologists and Canterbury City Council identified the historic importance of Vale Farmhouse and have insisted that the structure be fully repaired while wider plans are considered.

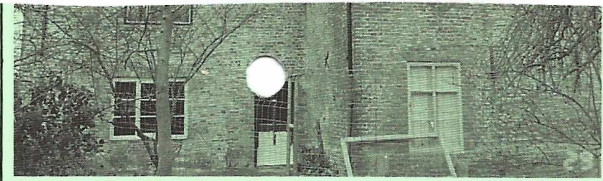
South side elevation showing the very bowed 1635 gable after repair.

Inside the brick exterior (which incorporates the dates 1635 and 1645 in the gable walls), are the remains of a 2-storey timber framed building, which maybe 100years older than the brickwork, and which was found to be in very poor condition.

A fully engineered scaffold was required to stabilise and enclose the building and support a temporary roof while the structure of the building was exposed for repair. Much of the work has concentrated on repairing and strengthening the timber frame, together with the intermediate floors and roof, in order that it can continue to support the walls until such time as the building's fate is decided.
