The Vanishing Houses of Kent.

A. Bridge Farm, Bridge

E. W. Parkin

Arch. Cant Vol LXXIX 1964.

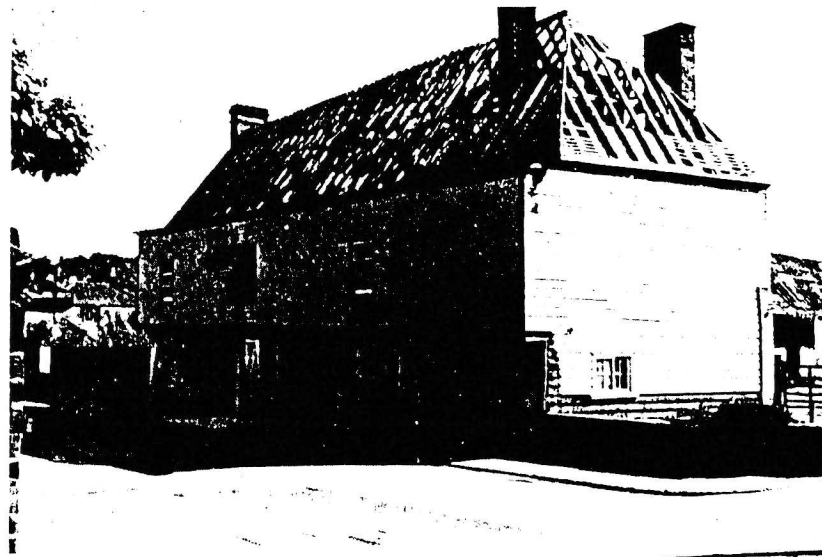
A. The house, seen from the road.

At first glance, the house appeared to be a very ordinary eighteenth-century one, with a front of stucco, sides of weatherboard, and with three small bays and a doorway on the street front (Plate IA). It was situated on the main Canterbury to Dover road, known as Watling Street, in the centre of the village and almost directly opposite the White Horse Inn. Behind it was a square farmyard with a large and ancient barn, two cow-sheds and other buildings (Fig. 1).

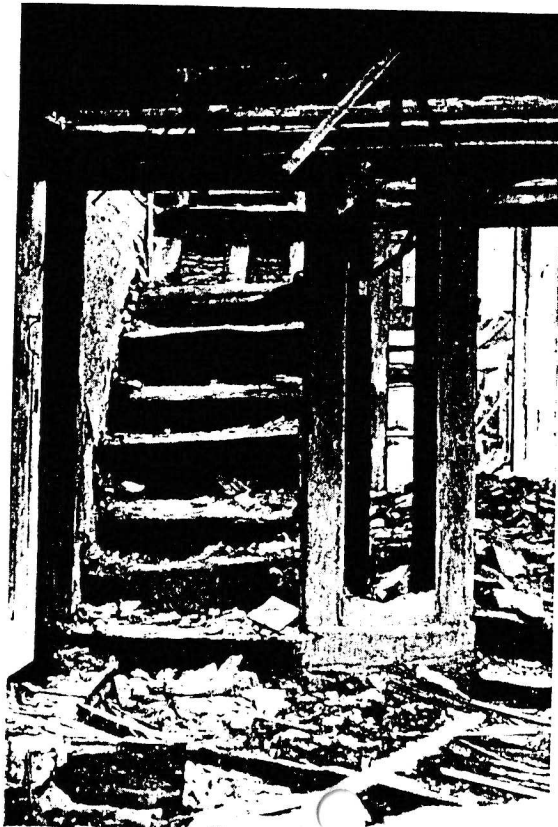
B. Remains of original stairway.

triangular section were nailed on to two sloping bearers, a third central bearer having been added at some later date. Each tread measured 3 ft. 3 in. by 7½ in., rising 8 to 9 in., the angle of the stairway being thus about 47 degrees from the horizontal. The bearers were 5½ in. wide by 3½ in. thick, and were nailed to a heavy beam at the top, and to a baulk of oak 8 in. square behind the door sill at the bottom. Each triangular step was fixed by only two large hand-made nails near the bottom edge, and although some of the nail heads had rusted completely away, all the steps except one were still firmly fixed (Fig. 3 and Plate IIB).
