THE VANISHING HOUSES OF KENT
A. BRIDGE FARM, BRIDGE

By
E. W. PARKIN

Reprinted from ARCHÆOLOGIA CANTUAR. VOL. LXXIX, 1964

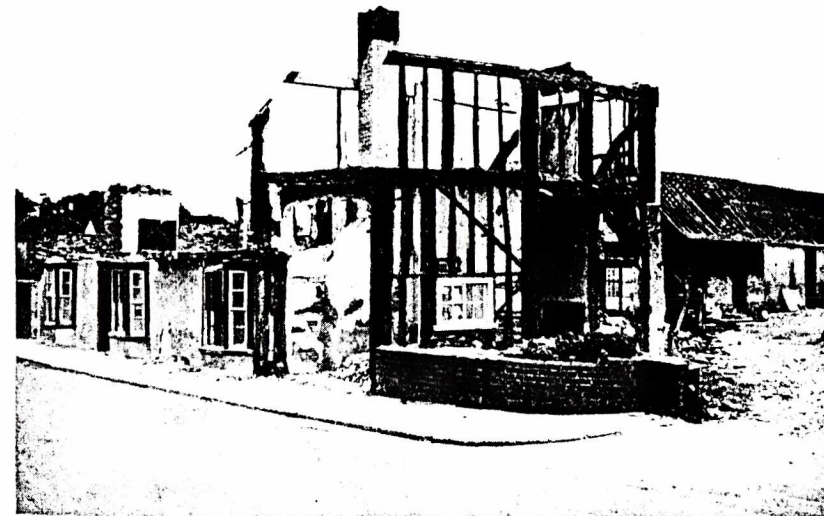
B. Same view later, showing wagon entrance.

The continuous jetty or overhang at the front gave the first clue that the house might be much older than it appeared, and as demolition proceeded, and the main timbers were exposed, this became increasingly evident. The right-hand end of the jetty proved to be false, and masked a fifteenth-century wagon entrance, which it will be noted, was in a direct line with the gateway into the farmyard. Over this wagon entrance was found a small medieval room complete with a transverse crown-post roof. The remainder of the house had once been a typical fifteenth-century Wealden house, with a central hall open to the roof, and small rooms each side of it, the upper ones being jettied out at the front. When wide brick fireplaces became the fashion in Tudor times, the open, central hearth was no longer needed, and an upper floor was usually inserted in the hall. In this house all evidence pointed to such an alteration having been made in the first half of the seventeenth century when a great fireplace was built at the rear of the old hall (Plate IIA) and an upper floor inserted, with joists protruding over the lower timbers, and giving now a continuous jetty on the street front as far as the wagon entrance. Windows of this period discovered under laths and plaster, confirm the date.

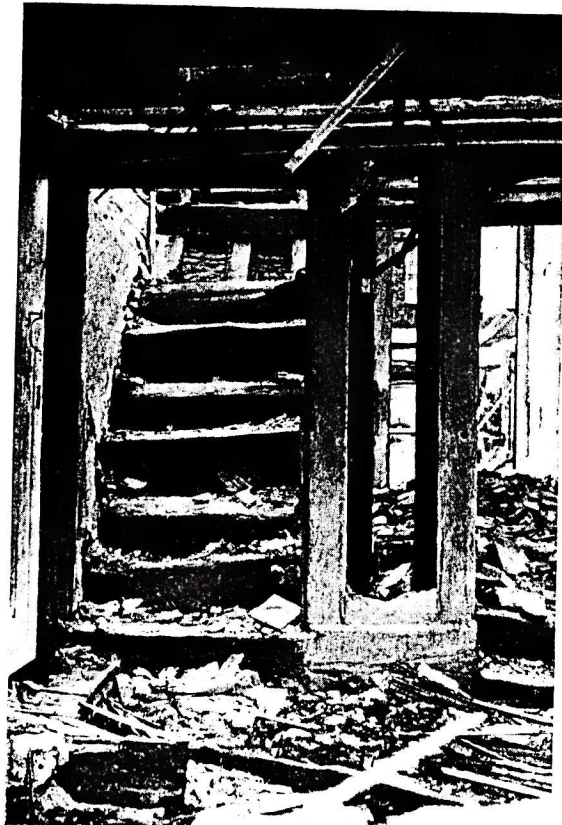
B. Remains of original stairway.

triangular section were nailed on to two sloping bearers, a third central bearer having been added at some later date. Each tread measured 3 ft. 3 in. by 7½ in., rising 8 to 9 in., the angle of the stairway being thus about 47 degrees from the horizontal. The bearers were 5½ in. wide by 3½ in. thick, and were nailed to a heavy beam at the top, and to a baulk of oak 8 in. square behind the door sill at the bottom. Each triangular step was fixed by only two large hand-made nails near the bottom edge, and although some of the nail heads had rusted completely away, all the steps except one were still firmly fixed (Fig. 3 and Plate IIB).
